Re: South Plant Maintenance Phase 1

## 2. CONDITION ASSESSMENT

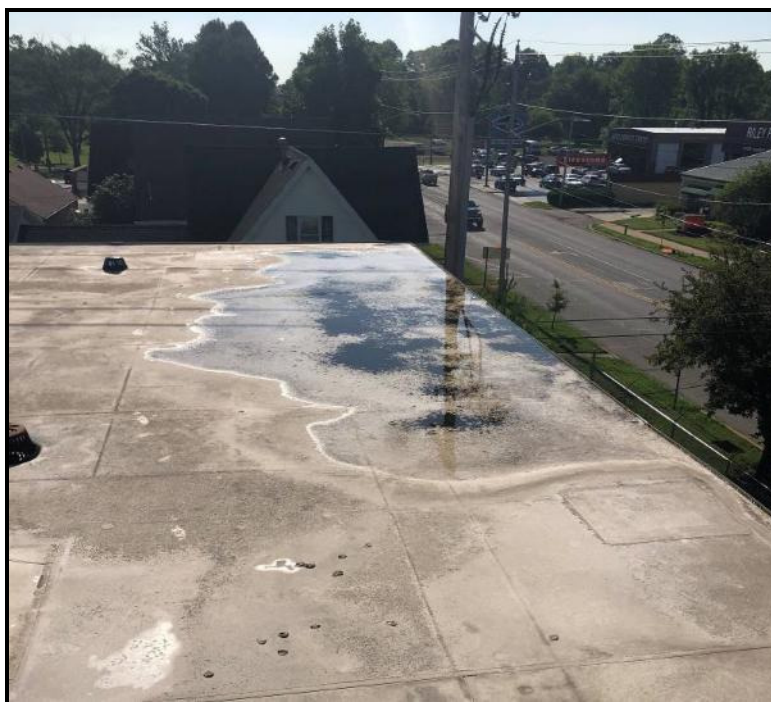
According to plant staff, the existing roof is approximately 15 years old and the warranty has expired. The roof is composed of a rubber membrane applied over a flat underlayment. The specific composition of the underlayment was not determined. By its inherent nature, a flat roof requires adequate water to build up on the surface before finally flowing to the roof drains. In the case of the main roof, localized ponding is occurring throughout the majority of the roof space. In certain locations, roof drains are set at a slightly higher elevation than the surrounding roof, further worsening the ponding problem. Figures 2-1 and 2-2 provide representative examples of observed roof ponding and the roof drain elevation concern, respectively.

**Figure 2-1** Representative ponding in the South East corner of the roof.

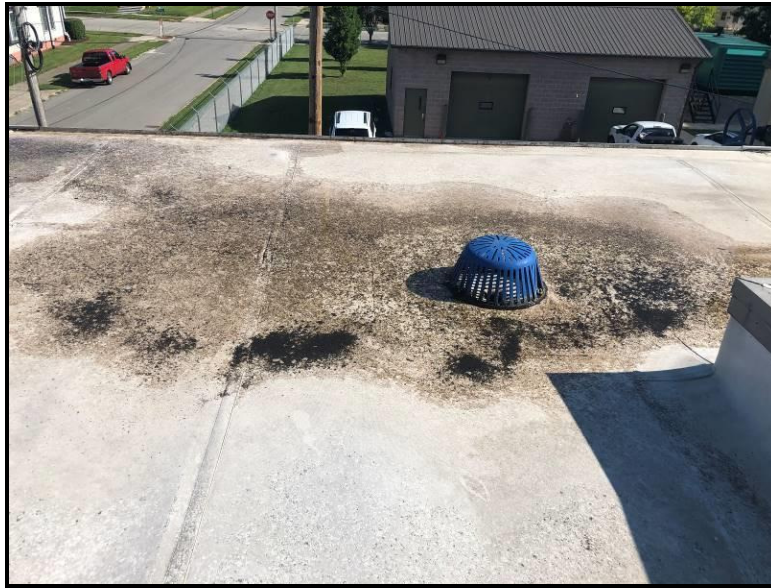
**Figure 2-2** Ponding around an improperly installed roof drain.

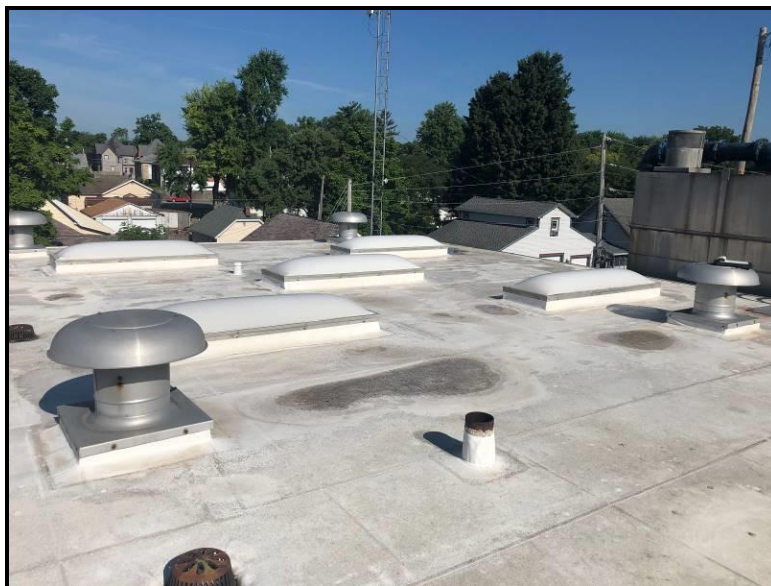
Five existing skylights over the filter room were also noted. These are in poor shape and lack the fall protection system required by building and safety codes. They further have been identified as a source of UV light infiltration into the filter room, encouraging algae growth in the filter cells. The roof access ladder was also noted as failing to meet modern code requirements. The existing HVAC unit in the north east corner of the building was in operation during the time of the assessment. Donohue noted, and brought to the Owner's attention, that the condensate drain trap on the east side of the unit previously froze and cracked. Condensate water was freely draining onto the roof as apposed to the roof drain as originally intended.

**Figure 2-3** Overall view of the upper roof including localized ponding and skylights.

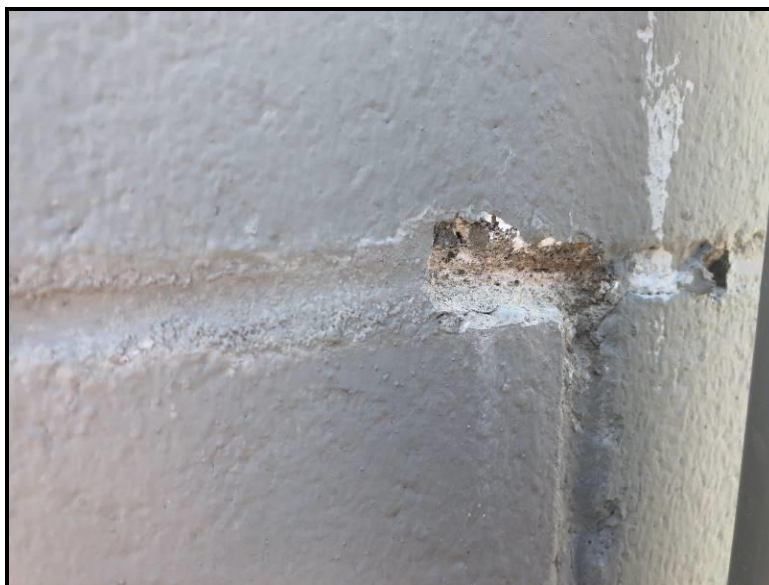
This space houses the aeration unit off the northwest corner of the building. The concrete deck shows only minor signs of cracking and deterioration which are anticipated for a structure of this age. Observations were made of previous brick repointing work which appears to have been done with a cement and fine sand mix. The mortar is very hard, likely harder than the original mortar, and was falling out in select locations. Further observation of the failed mortar revealed that the previous replacement depth did not always meet standard repointing recommendations.

**Figure 2-4** Failed repointed mortar joint adjacent to the intermediate roof deck.
